**National Highway
Traffic Safety
Administration**

Case Vehicle (A): 1998 Buick
 Type: Century Custom, 4-door sedan
 Driver: 70-year-old female
 CDC: 12-FDEW-2, 00-TDDO-4

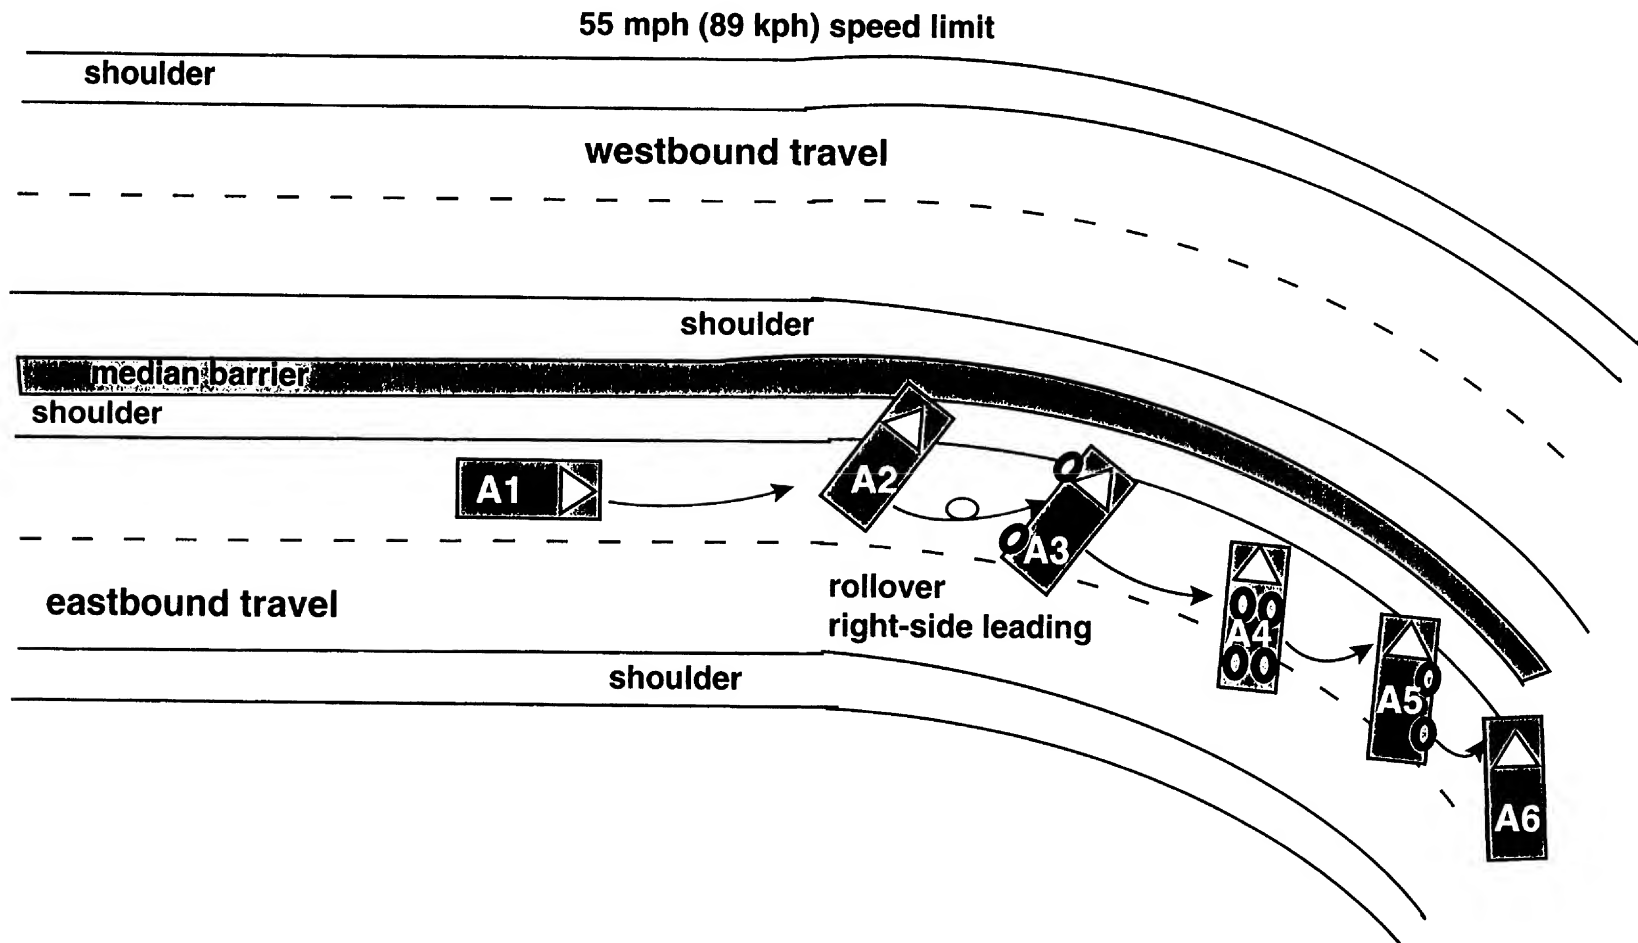
ACCIDENT SCHEMATIC

ACCIDENT DESCRIPTION: CASE VEHICLE (A) WAS TRAVELING EAST AT AN UNKNOWN SPEED IN THE LEFT LANE OF A LIMITED-ACCESS HIGHWAY. THE DRIVER REPORTEDLY FELL ASLEEP WHILE DRIVING, EXITED THE LANE LINE AND NORTH SHOULDER, AND STRUCK A CONCRETE BARRIER WALL WITH IT'S FRONT. AFTER THE IMPACT, THE VEHICLE ROLLED OVER AT LEAST 360° WITH ITS RIGHT-SIDE LEADING. IT CAME TO REST ON ITS WHEELS.

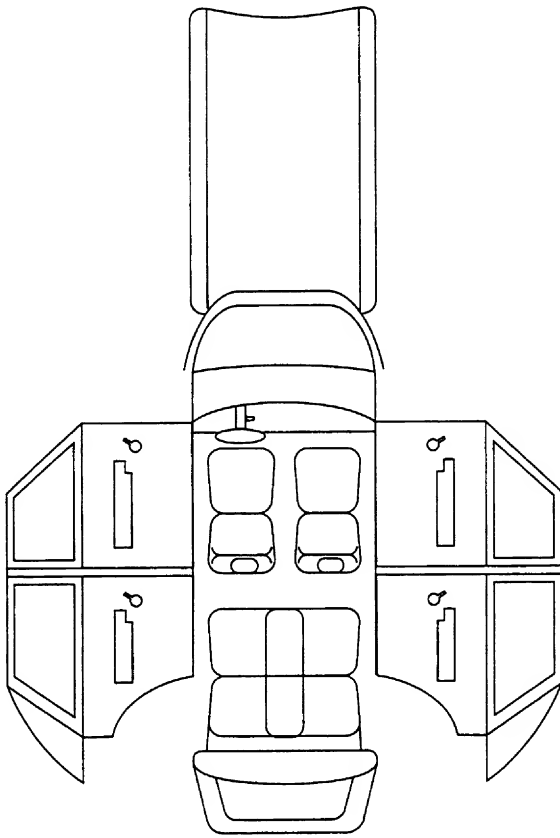
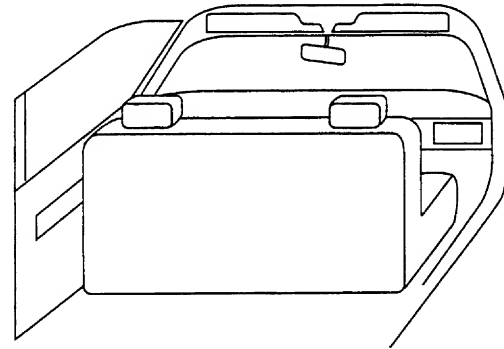
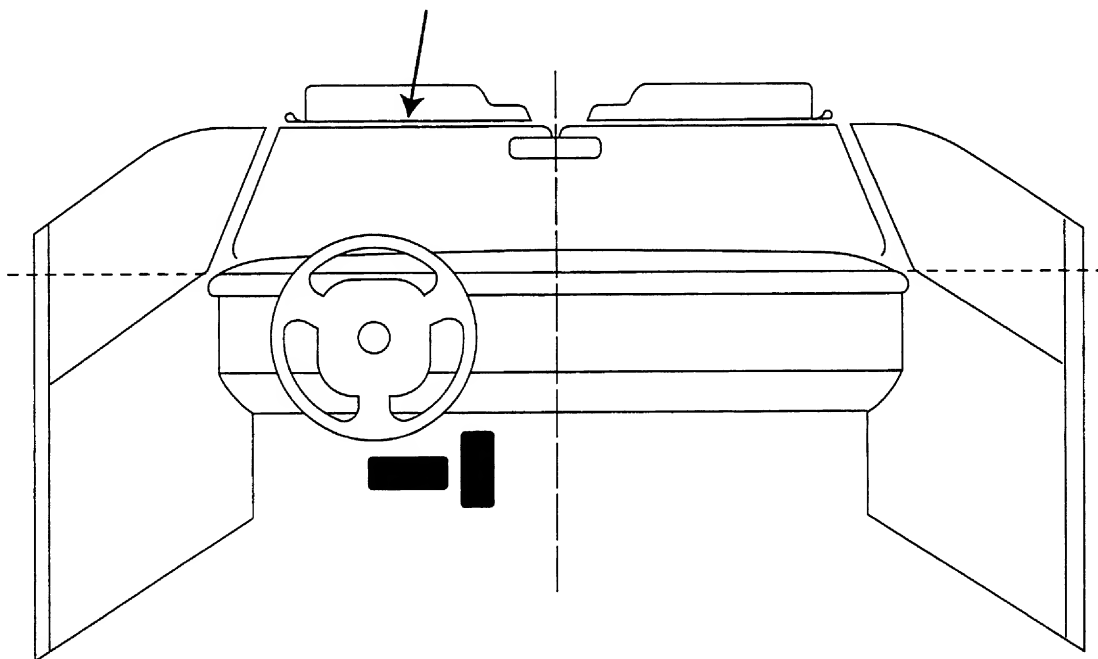
VEHICLE OCCUPANT CONTACT DIAGRAM

DR BELT: adjusted to
low position on B-pillar

(A) sunvisor

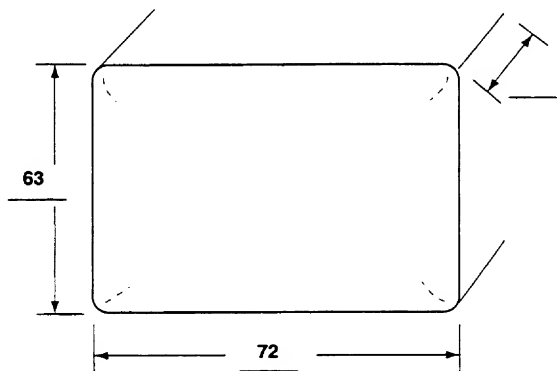
Passenger Airbag

Flap contacted windshield

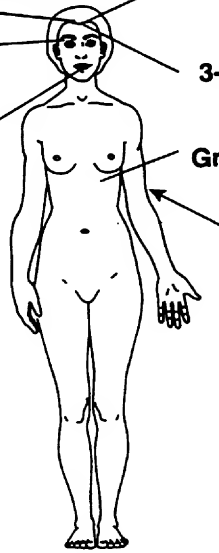
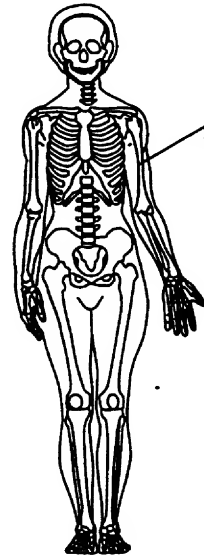
Grade-I laceration, spleen
(2)

3-cm laceration,
left elbow
(1)

Non-displaced
incomplete fracture,
left humerus
(2)
